GEOTECHNICAL INVESTIGATION

**FANITA RANCH
FANITA COMMONS,
ORCHARD VILLAGE
AND VINEYARD VILLAGE
SANTEE, CALIFORNIA**

**HOMEFED CORPORATION
CARLSBAD, CALIFORNIA**

**APRIL 17, 2020
PROJECT NO. 05254-32-18A**

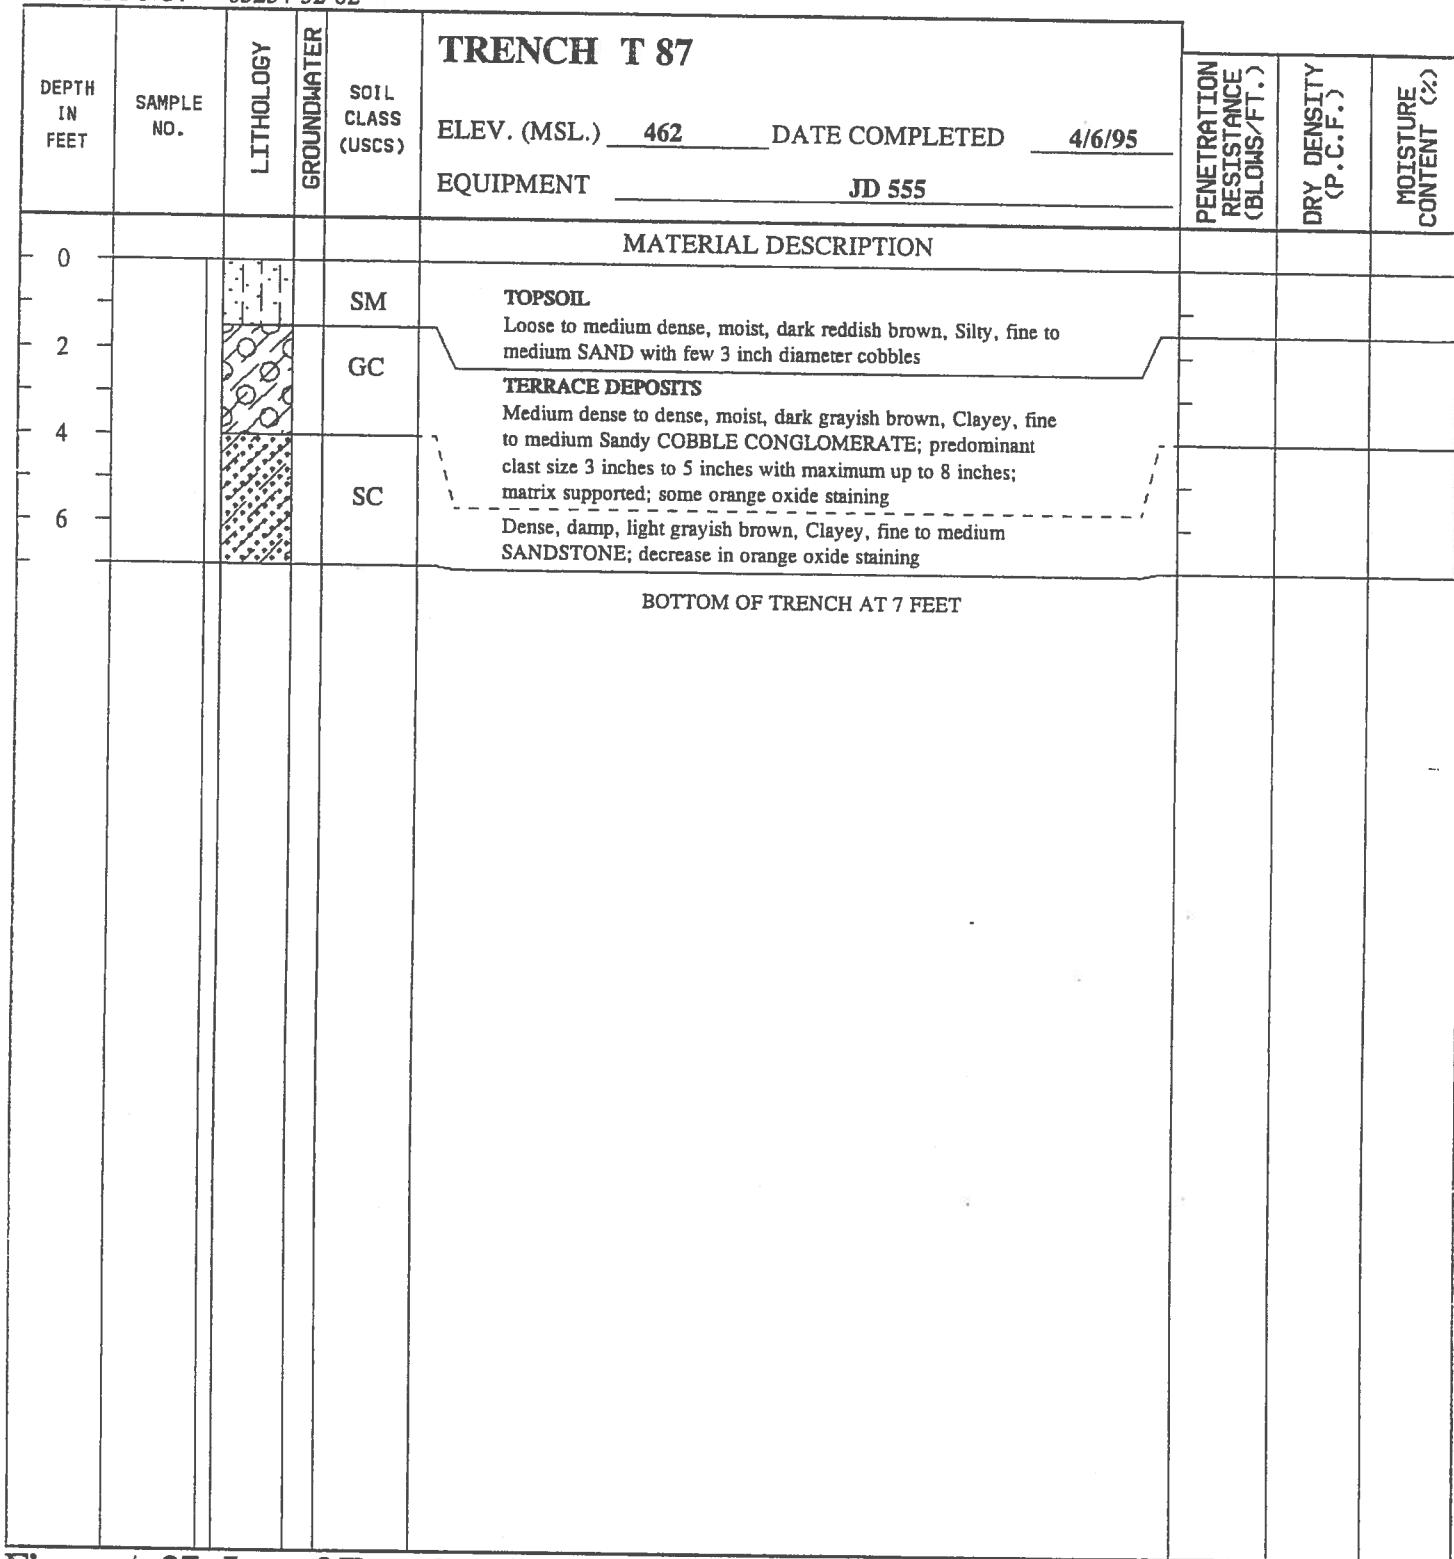
Figure A-27, Log of Trench T 87

Terrace Deposits were encountered along the flanks of Sycamore Creek (Trench No. T-87). These deposits are relatively limited in extent and consist of locally cemented, medium dense to dense, damp to moist, orange/grayish brown gravelly cobble conglomerate and clayey sand. In several areas, the Terrace Deposits were not differentiated from the conglomeratic facies of the Friars Formation. Terrace Deposits will likely be encountered during grading for the westernmost portion of Fanita Commons and Orchard Village.
