SUPPLEMENTAL GEOTECHNICAL INVESTIGATION

SANTEE YARD PROPERTY MISSION GORGE ROAD SANTEE, CALIFORNIA

CAMERON BROS.
CONSTRUCTION COMPANY, INC.
SANTEE, CALIFORNIA

MARCH 9, 2022 PROJECT NO. G2332-11-01

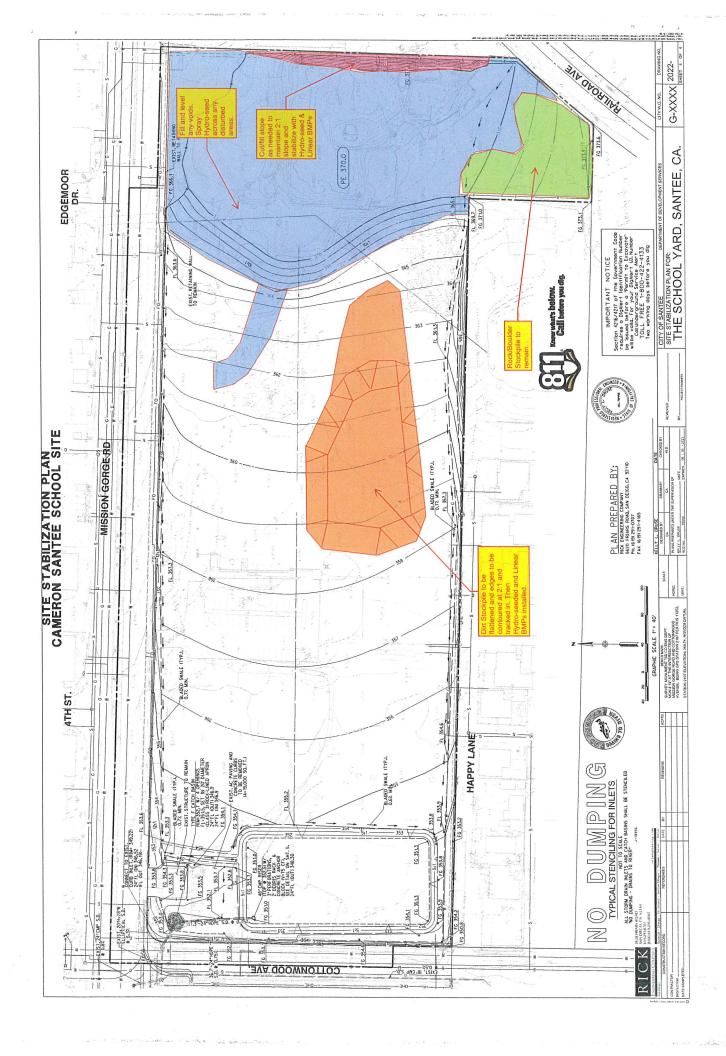
Site Stabilization Plan

It is recommended that the soil stockpile be leveled off at the top and the side slopes tracked or rolled to create slopes no steeper than 2:1 (horizontal to vertical). The same procedure should occur within the eastern portion of the site where the granitic rock excavations occurred. All voids should be infilled in the eastern area. Linear BMP's should be installed along the perimeter of the stockpile and eastern excavation zone. Both disturbed areas should be sprayed with a dry hydroseed mix to stabilize the soil and reduce the potential for erosion.
